Debugging a Mixed Signal Design with a Tektronix Mixed Signal Oscilloscope

Introduction

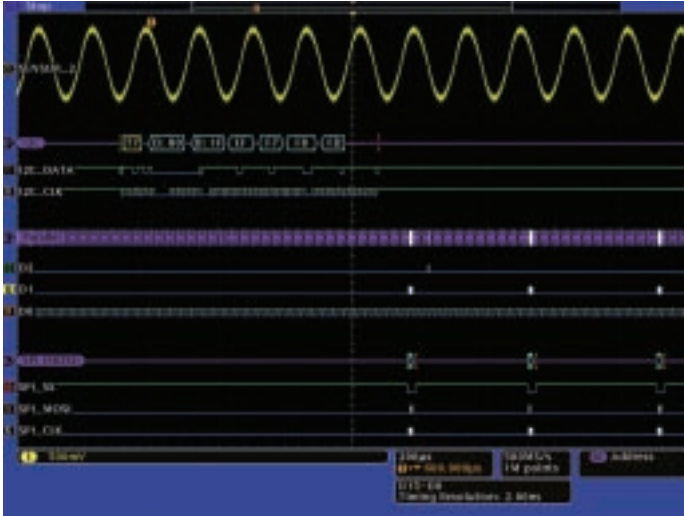
Figure 3. MSO4000 displaying I²C, SPI, and parallel buses with CH1 analog.

Figure 3 shows a screenshot from probing the SPI bus (1), I²C bus (2), 3-bit parallel bus (3), and analog input (4) at the same time. Since the error could be isolated to a particular subroutine, the oscilloscope was configured to take a single acquisition that triggered on particular I²C activity. Setting the record length to 1M points guaranteed that all the useful information around the event on the I²C bus would be accurately captured. The engineer ran the subroutine and quickly referred to the MSO Series to see what had happened in the system. The clean analog waveform at the input of the MUX shown on CH1 confirmed the engineer's suspicion that the hardware had been fixed, and the error was occurring elsewhere. The oscilloscope triggered on and decoded the I²C data being written from the microcontroller. The engineer noticed activity on the SPI bus and the displayed signals labeled D1 and D2 shortly after the I²C data was transmitted. The activity on these buses was suspicious because the executed function was supposed to primarily involve the LCD controller. Because the oscilloscope had already decoded the value of the I²C data, the engineer could see that the microcontroller had written I²C data to address 0x77. Address 0x77 is the address of the FPGA,

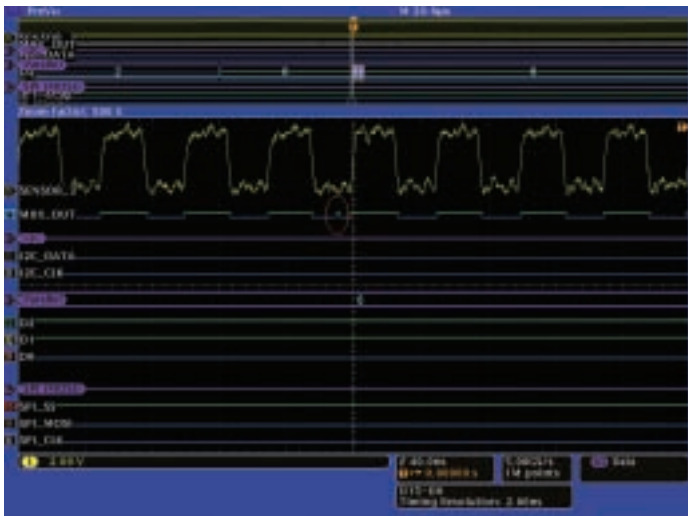
Figure 6. Wave Inspector® reveals a glitch on the MUX_OUT signal.

Figure 6 shows the timing correlation between the analog and digital channels in the MSO Series. The input to the MUX is displayed on CH1 (SENSOR_3) while the MUX output is observed on digital channel D14 (MUX_OUT). The engineer noticed that although the MUX output had a glitch, the input to the MUX appeared glitch free. After identifying the glitch with the digital channel, the engineer decided to take a closer look by connecting CH2 to the MUX output. Figure 7 shows the resulting acquisition with the oscilloscope still configured to trigger on the parallel bus value 0x7. The waveforms for the

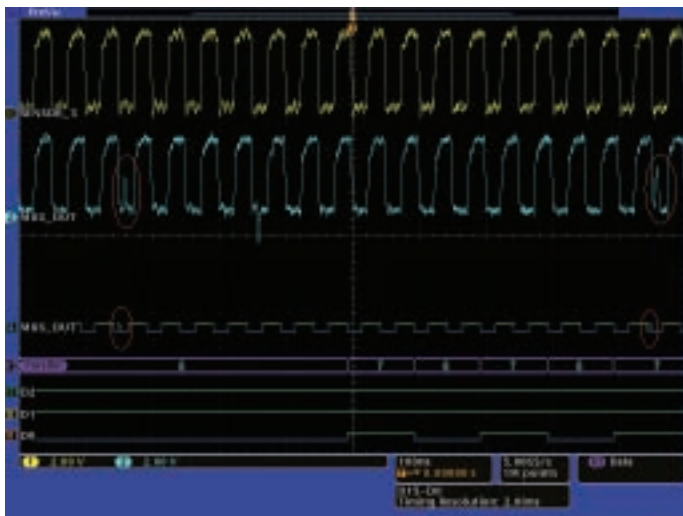
Figure 7. CH2 shows more detail for MUX_OUT.

SPI and I²C buses have been turned off in Figure 7 to focus on the primary signals of interest. Using the analog probes on the MUX input and output revealed that glitches present on the output are not present on the input signal. Figure 7 shows that a glitch on the MUX_OUT signal appeared a short time before the FPGA sent the error code. The timing relationship between these two signals indicated that the glitch could be the problem the engineer had observed. The engineer repeated the acquisition several times with the same configuration, and observed behavior similar to Figure 7 in every case.
